IDAHO CAPITOL RESTORATION

Department of Administration
Construction Update No. 53
January 17, 2006

Capitol Skylight Repairs to Finish by Spring

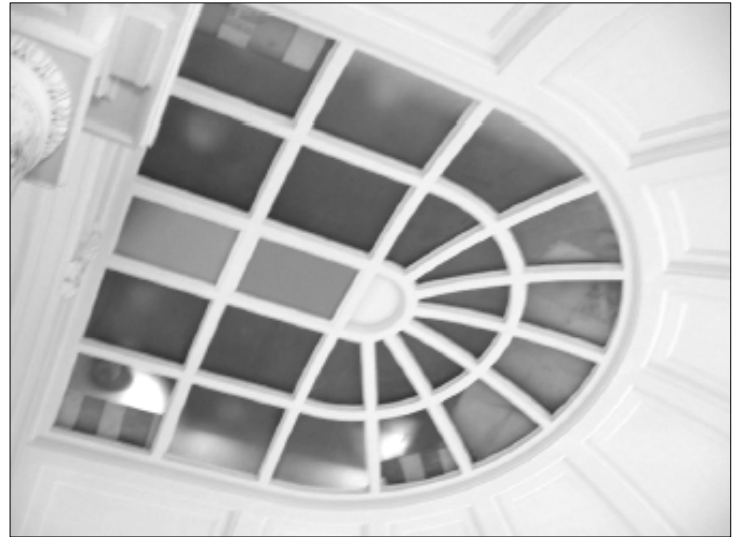
Work was also set to proceed on the large north skylight over the Joint Finance and Appropriations Committee room (**above photo**). Just last week, however, contractors discovered a problem with the newly fabricated framing for the JFAC skylight, which had been scheduled for completion the end of December. Consequently, this portion of the repair will be delayed about a month, according to **Jan Frew**, Deputy Administrator, Division of Public Works.

In the interim, plywood sheathing and a temporary roofing membrane will be in place until the replacement skylight can be installed. **When the parts do arrive, work will be scheduled around legislative activities to minimize noise concerns.**

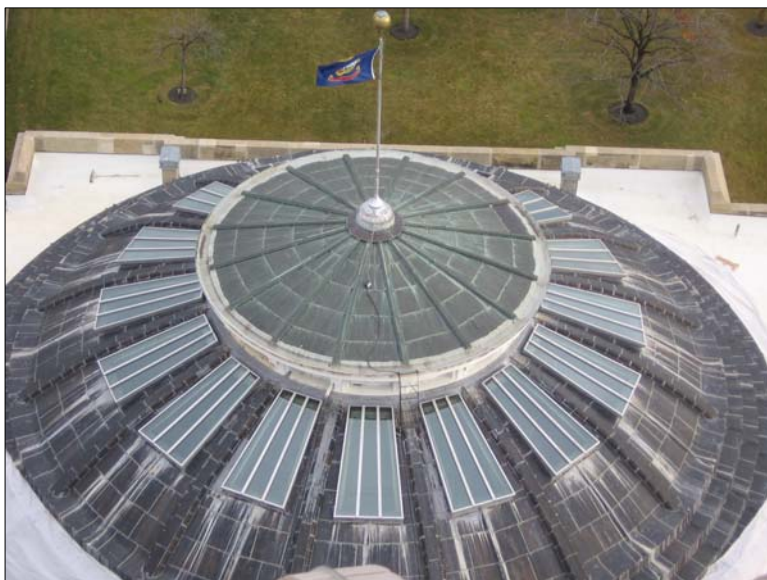
(Photo at Left: New skylights have been installed over both Legislative chambers).

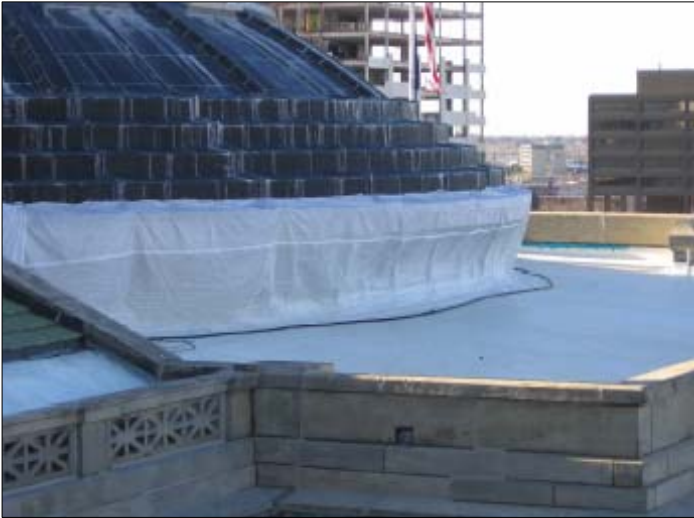
Top Photo Left: West Cupola with temporary protection covering cast stone repairs.

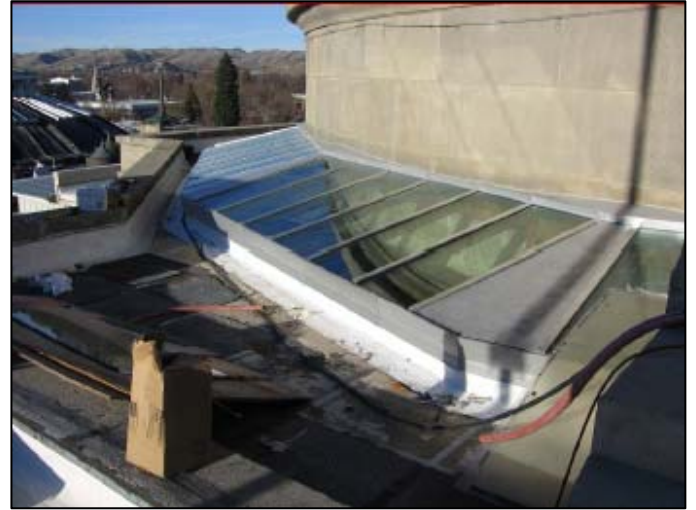
Top Photo Right: Skylights surrounding the Rotunda were replaced with aluminum frame and laminated glass skylights for extra impact resistance due to falling ice from the dome.

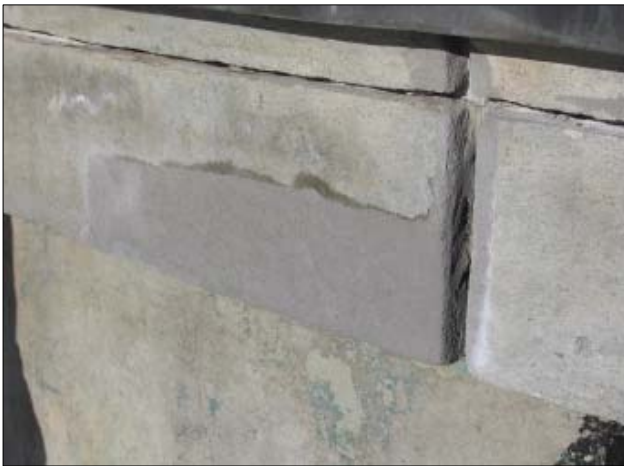
Bottom Photo Left: The cast stone cement patching process is almost done. Work remaining includes sealing cast stone joints, grouting and sealing cracks in the stucco and applying an elastomeric coating to all the cast stone and stucco surfaces found at the base of the East and West Cupolas.

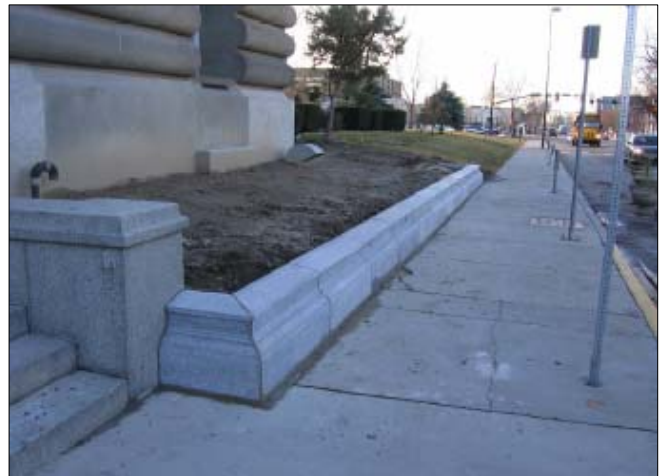
Bottom Photo Right: West granite planter wall is nearing completion.
